## Mine remediation in New Zealand Lessons from the (recent) past

Jenny Webster-Brown

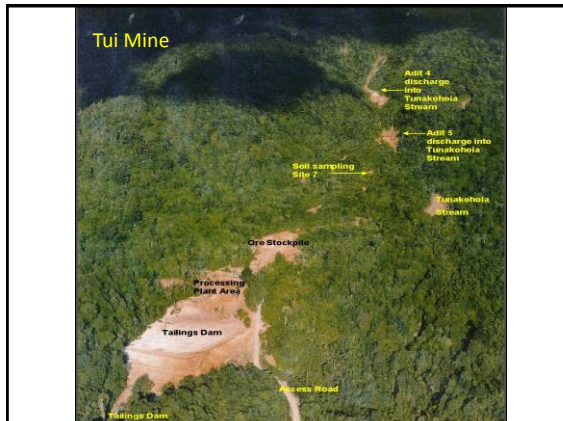
Tui mine adit drainage:

- Reporting to Tunakohoa Stream
- Copious Fe oxide
- Neutral pH
- High Zn and Cd.
